TECHNICAL REPORT ARCCB-TR-98014

**FAILURE ANALYSIS OF AN 84-MM, M3,  
CARL GUSTAF, RECOILLESS RIFLE**

**US ARMY ARMAMENT RESEARCH,  
DEVELOPMENT AND ENGINEERING CENTER  
CLOSE COMBAT ARMAMENTS CENTER  
BENÉT LABORATORIES  
WATERVLIET, N.Y. 12189-4050**

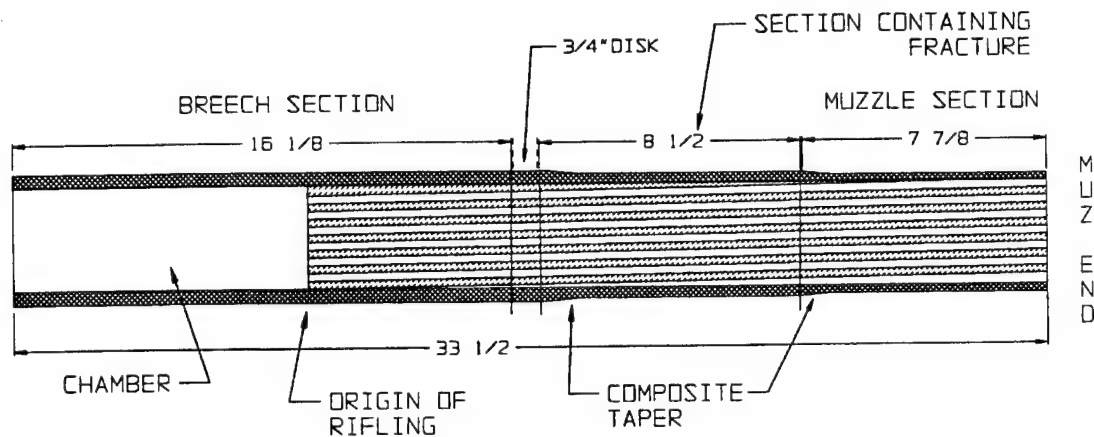
Figure 2. Barrel specimen cut location sketch

The barrel was cut into several sections, as shown in Figure 2. A 16.125-inch long, breech fatigue specimen was cut from the barrel for possible use in the Multi-Role, Anti-Armor, Anti-personnel Weapon System (MAAWS) Gun Life Study. The section from the muzzle to a distance of 8 inches into the barrel was also sectioned off and set aside. The failure zone, which included 8 inches from the muzzle point to a distance of 16.5 inches from the muzzle, was removed and cut in half lengthwise (from 1:00 to 7:00) to expose the liner crack for analysis. The small remaining section was polished on one side and used to measure liner thickness and evaluate laminate and liner quality. Before cutting, a piece of tape was placed over the liner crack on the bore surface to capture any debris that may have fallen out during the cutting operation.

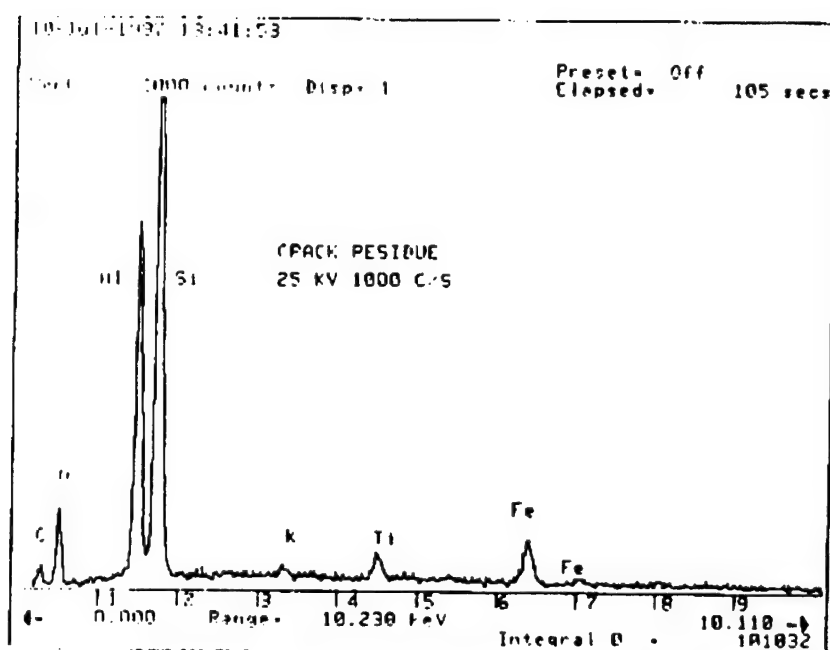
**FIG. #2**

2. Figure 2 shows material that was extracted *in situ* from a portion of the liner crack before sectioning. Figure 2A is an "elemental map" of the same area and shows the extracted particles to be rich in Si. The EDX spectrum from this material (shown in Figure 2B) indicates a strong Al presence. Many extracted particles were equiaxed, but others appeared to be film-like. Figures 3 and 3A show large particles near the crack that were also rich in Al and Si. EDX spectra from equiaxed particles were always rich in Si and/or Al.

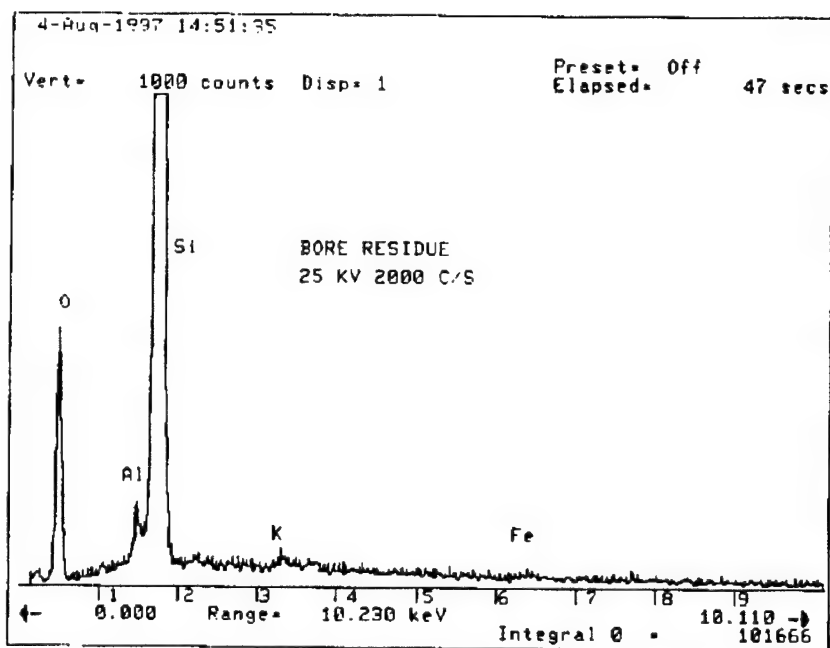
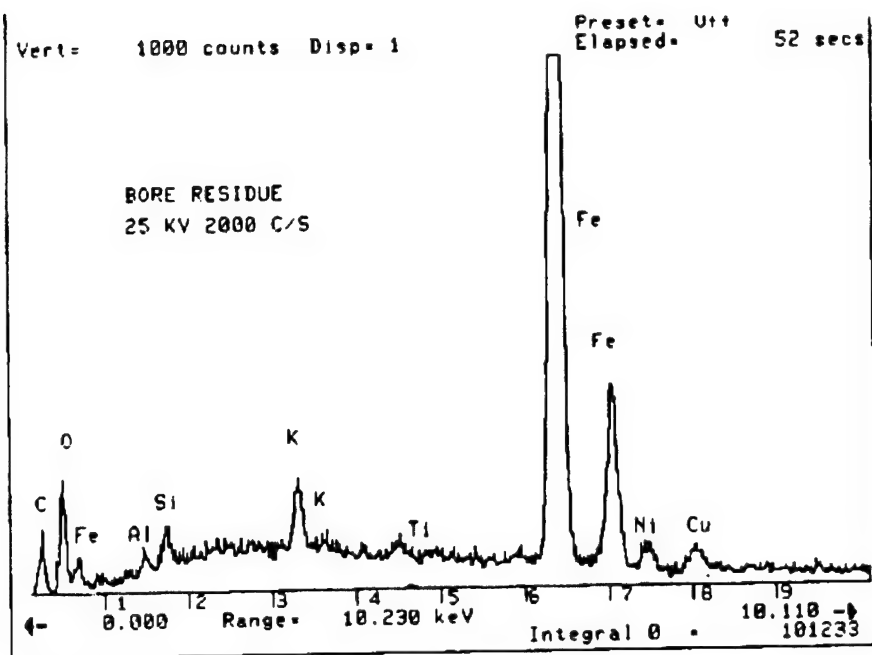
**FIG. #4**

Figures 4 through 4D are from particles that were extracted from the liner on the breech side of the crack. This area displayed a reddish appearance. Figure 4 shows a land/groove junction, while Figures 4A and 4B are Si and Fe maps, respectively, from this same area. The pictures show that large, equiaxed, Si-rich particles were concentrated in the

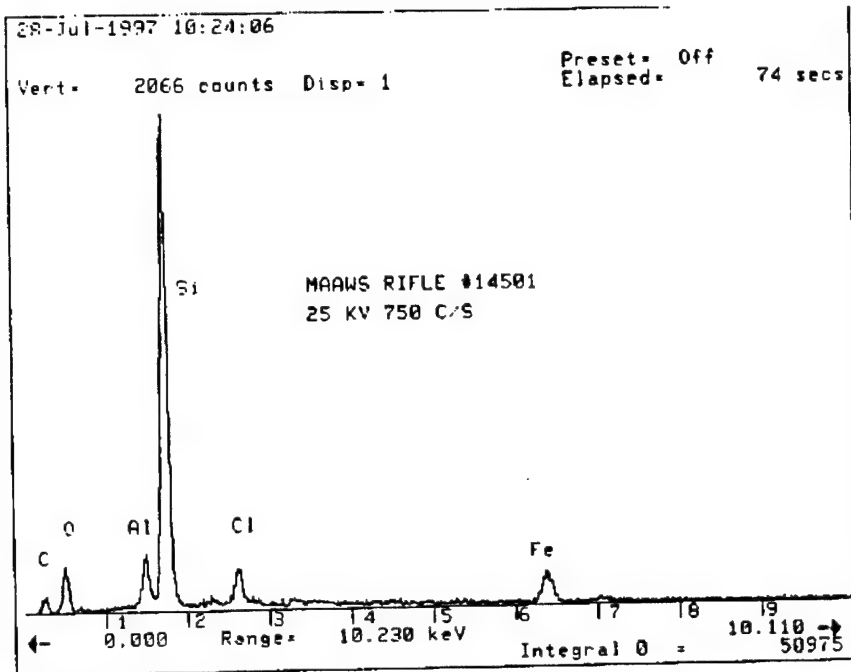
**FIG. #5**

3. The cracks on the composite outer diameter and the liner inner diameter were protected with plastic tape while the liner crack was cut to fit into the SEM. (During this cutting, the composite delaminated from the liner.) Figures 5 and 5A show a portion of the liner crack after sectioning. Figure 5 shows debris *in* the crack, while Figure 5A shows the debris to be rich in Si. The crack showed no evidence of brittle fracture.

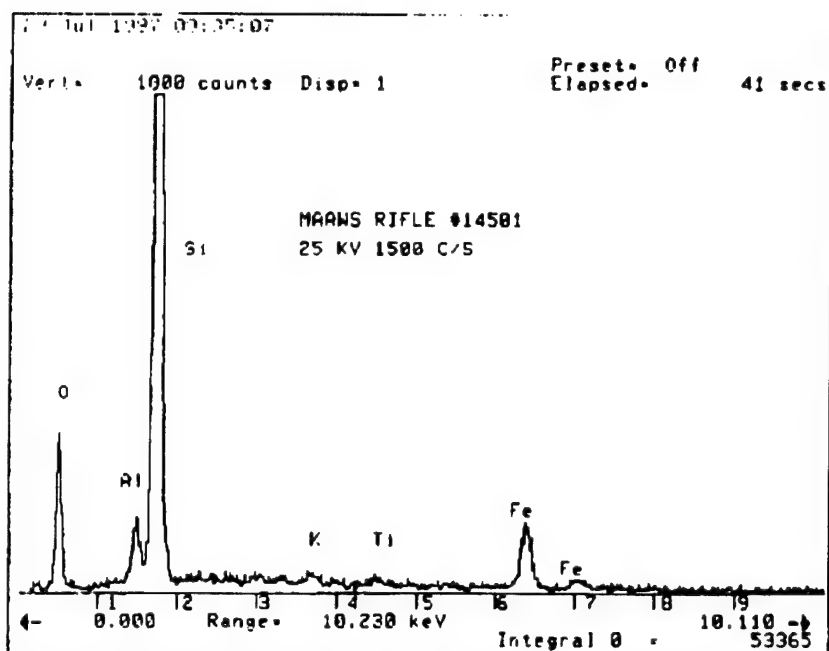
**FIG. #6**

4. The crack was then "broken open." Figure 6 shows a typical fracture surface (F), with debris still covering much of the separation. This debris was consistent with silica (Figure 6A). The debris was removed via tape to reveal the fracture mode. Figure 7 shows a typical fracture surface (F), while higher magnification (Figure 8) shows the fracture mode to be shear, which is consistent with a single cycle, tensile overload.

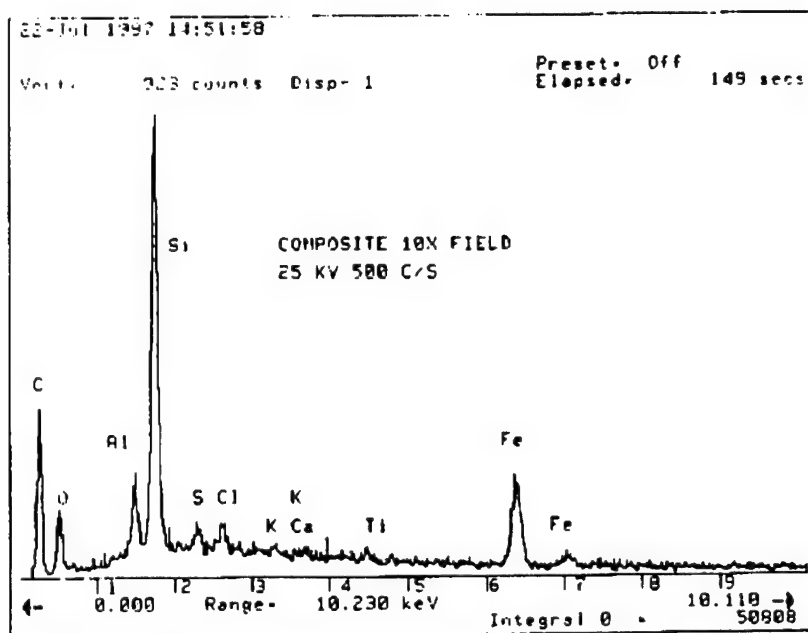
**FIG. #9**

5. Figures 9 and 9A show a portion of the crack in the composite, at what had been the composite/liner interface. The elemental map in Figure 9A and the EDX in Figure 9B reveal Si-rich material in and around the crack. EDX analysis of the particle-free composite showed only material consistent with the composite.

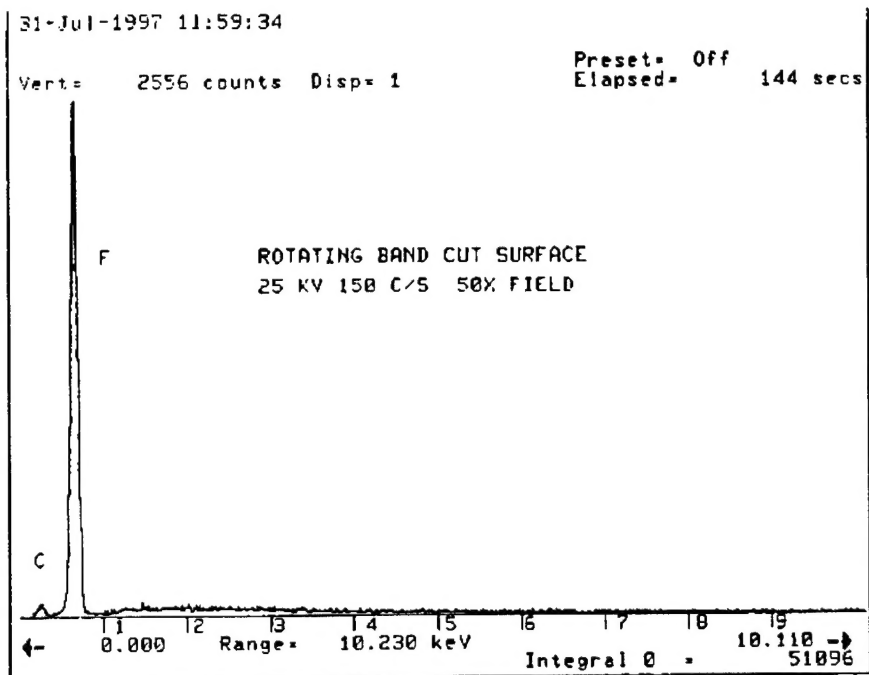
**FIG. #10**

6. EDX spectra from interior cut surfaces of a rotating band (Figure 10) showed only F and C, which is consistent with teflon (PTFE).
7. These results show that a large amount of foreign material was present on the inner diameter of the rifle bore. In addition to being deposited on the bore surface, this material was also embedded in the bore crack—to the extent that it completely penetrated through the crack to the composite. This suggests that a large amount of foreign material was present before and during the firing of the last round—the action of which forced the material into the growing crack. At a minimum, the presence of this foreign material was probably a contributing factor to this failure. EDX spectra from this material were consistent with clay, silica, and/or feldspar but do not provide a positive identification. However, it appears that—unless another source of an Si-rich substance is identified—this foreign material most probably represents area soil. A site soil sample should be evaluated.
